FA Log #: 6913	DPA Analyst: J. Okuno	DPA Result: Fail
Part Name and Number: Hybrid DC/DC Converter, 2690M-T12F		
Mfg: Modular Devices, Inc.	Date Code: 9648	Serial #: 2025
JPL Trace #: None	Project: MVACS	Subsystem:

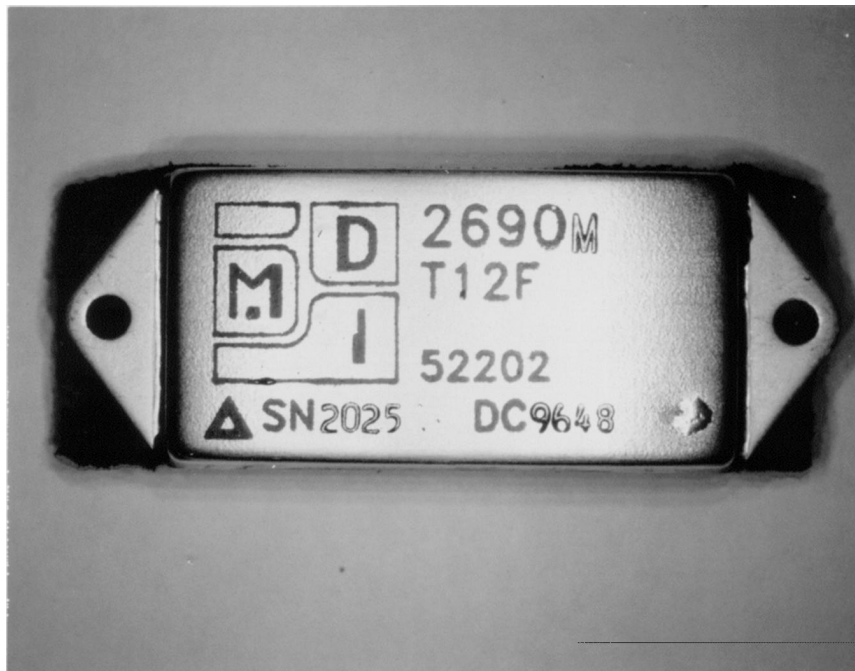
Figure 1. Optical photograph showing part top markings.

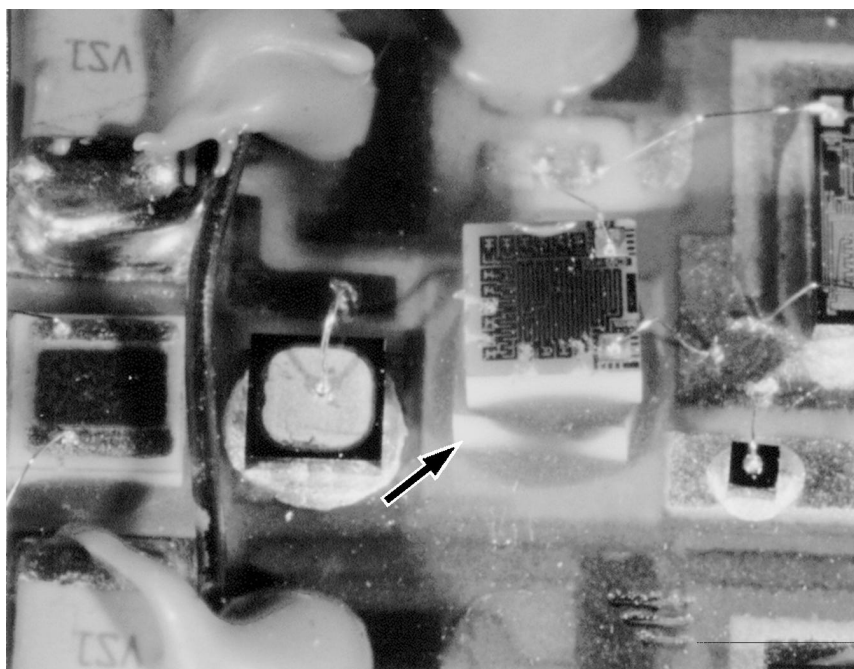
Figure 3. Optical photograph showing a reworked resistor chip stacked atop an unused chip (arrow).

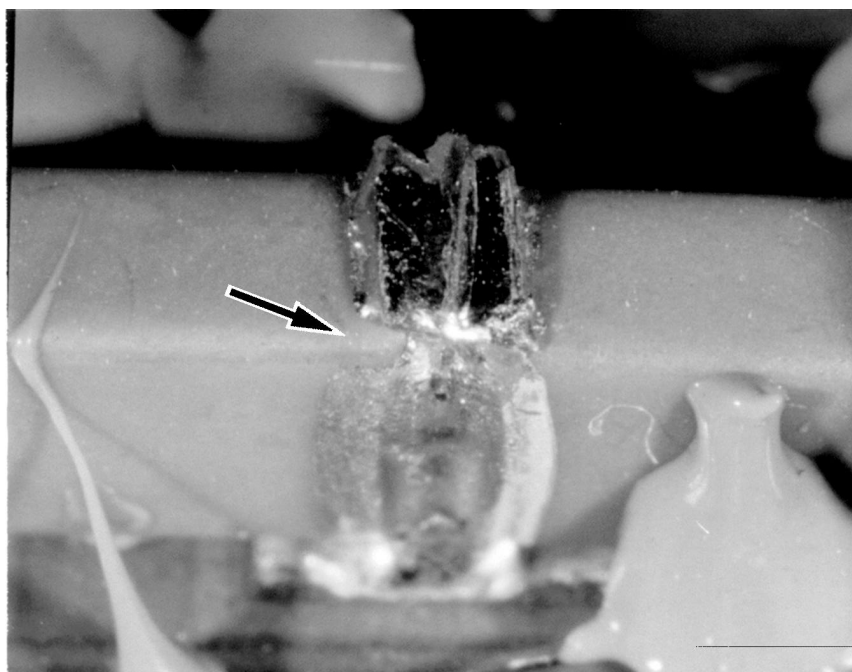
Figure 4. Optical photograph of missing endcap metallization on a ceramic chip capacitor.

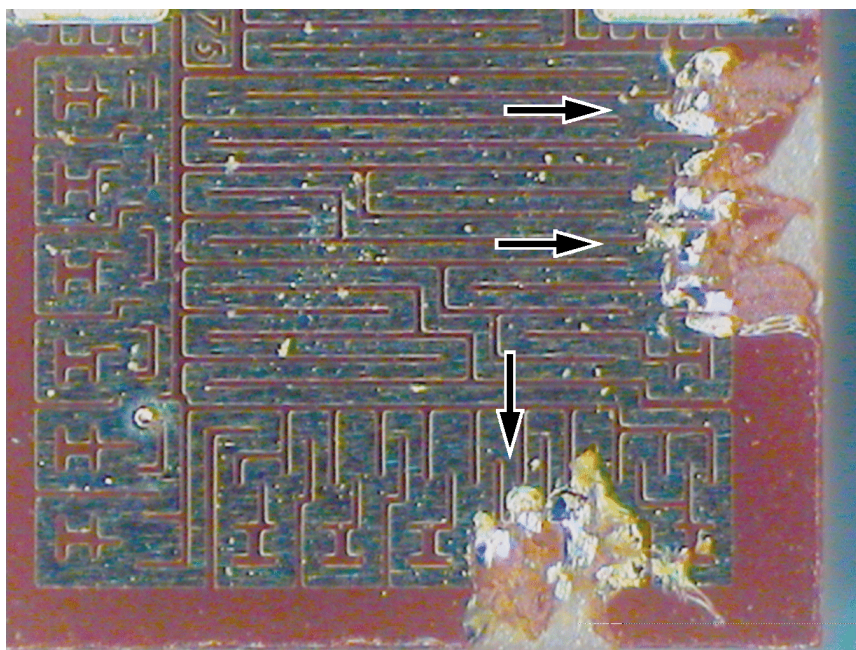
Figure 5. Optical photograph showing the top surface of the reworked resistor (same as Figure 1). The resistor has been trimmed roughly with a mechanical probe as indicated by the arrows.

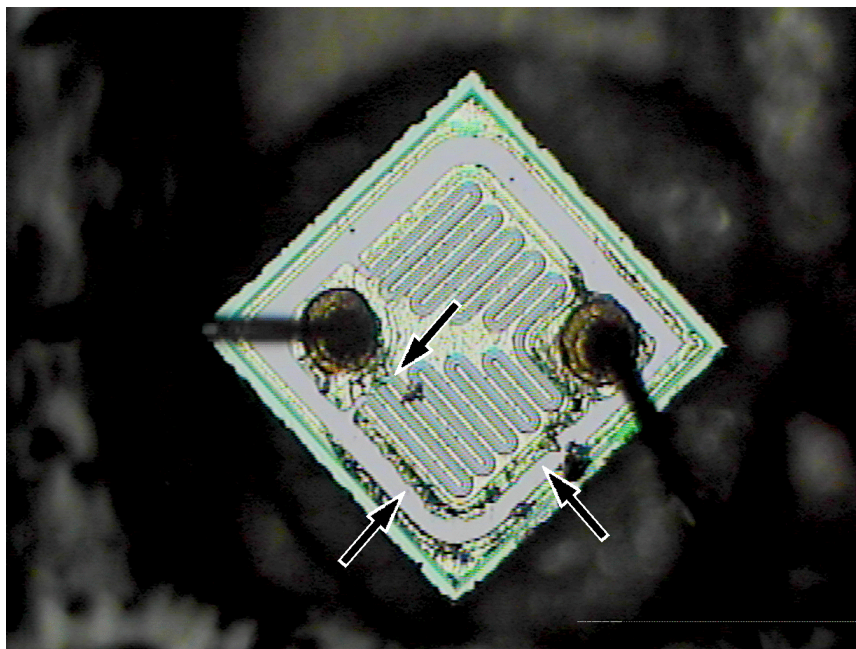
Figure 6. Optical photograph showing damaged die surface metallization (arrows) on a transistor.
